DEPARTMENT OF TRANSPORTATION

Quality Assurance and Source Inspection

Contract #: 04-0120F4Cty: SF/ALA Rte: 80 PM: 13.2/13.9File #: 1.28**WELDING INSPECTION REPORT****Resident Engineer:** Casey, William**Address:** 333 Burma Road**City:** Oakland, CA 94607**Report No:** WIR-029752**Date Inspected:** 21-Jun-2013**Project Name:** SAS Superstructure**OSM Arrival Time:** 700**Prime Contractor:** American Bridge/Fluor Enterprises, a JV**OSM Departure Time:** 1730**Contractor:** American Bridge/Fluor Enterprises, a JV**Location:** Jobsite**CWI Name:** See below**CWI Present:** Yes No**Inspected CWI report:** Yes No N/A**Rod Oven in Use:** Yes No N/A**Electrode to specification:** Yes No N/A**Weld Procedures Followed:** Yes No N/A**Qualified Welders:** Yes No N/A**Verified Joint Fit-up:** Yes No N/A**Approved Drawings:** Yes No N/A**Approved WPS:** Yes No N/A**Delayed / Cancelled:** Yes No N/A**Bridge No:** 34-0006**Component:** Bikepath piping; OBG deck; OBG Barrier Ra**Summary of Items Observed:**

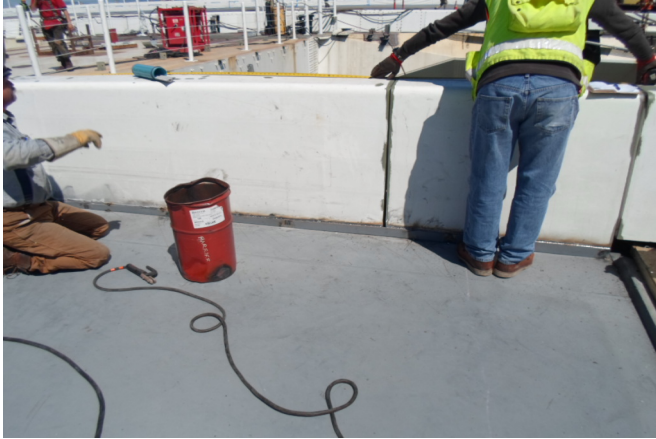
Welding was witnessed by this QAI being performed of 2-1/2" diameter water piping full penetration butt splice by F.W. Spencer welder Tim Esquivel #8348 utilizing E6010 electrodes for the root pass and E7018 electrodes for the fill and cap passes as per the approved WPS #1. The location of the weld performed was at Bikepath PP109. The AB/F Quality Control (QC) Inspector Fred Michels was present, monitoring the WPS parameters of the welding in progress.
